Photos of Grocery Store
Emergency Repair

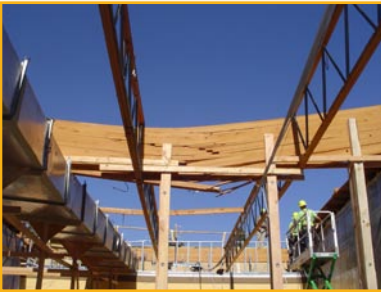
Broken Beam

It was Friday afternoon of the Labor Day holiday weekend. Students at the college town of Chico, California were celebrating the end of classes and were out shopping for party supplies. Without warning, **a beam supporting the roof of the favorite local supermarket collapsed**, prompting evacuation of the store and a lockout by the local fire dept.

Within hours, our crews were on site with an engineer. Working through the night, we surveyed the damage with the engineer. At 7AM the next morning, we began installation of temporary shoring in order to support the roof and ensure the building would be safe for the public. By 6PM, city officials and the fire department deemed the structure safe and doors were reopened to the public. **Thanks to EFA, one of the busiest shopping weekends of the year was salvaged for this business.**

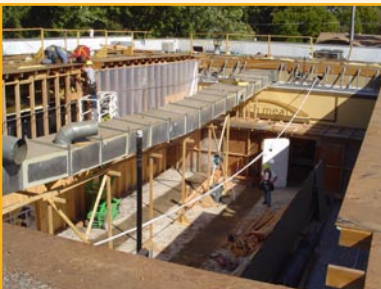
Open Roof

After approval of a budget for repairs, we returned for a permanent repair. The job involved removing a 40' x 80' section of roof, hoisting the damaged beam and trusses through the opening, and lowering and installing a replacement beam and trusses specified by the engineer. **This was all accomplished while the store remained open for business.**

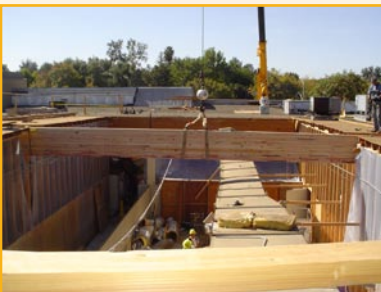
New Beam
